Inspection Report

Advantage Inspection Upstate Inc.

146 City Scape Dr Greenville SC 29681

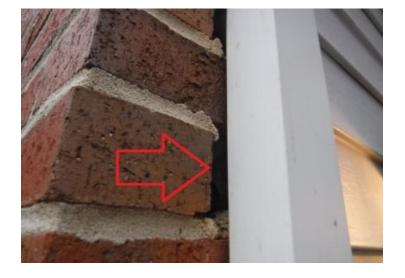
Gaps noted between brick and vinyl siding along the front porch and at the front right corner of the home. Recommend having a qualified person properly seal the gaps to eliminate water penetration.

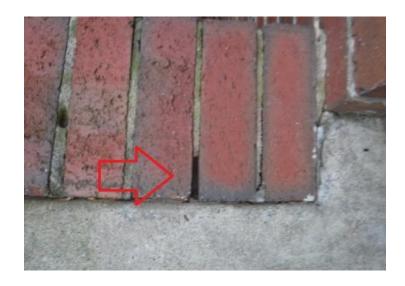
Loose mortar joints noted along the front porch and porch steps. Recommend having a qualified person properly seal the loose mortar joints to prevent settling from water penetration.

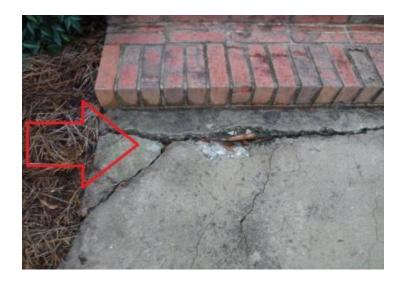
The walkway has settled and is damaged beside the front porch steps. Recommend having a licensed contractor evaluate the sidewalk and make necessary repairs.

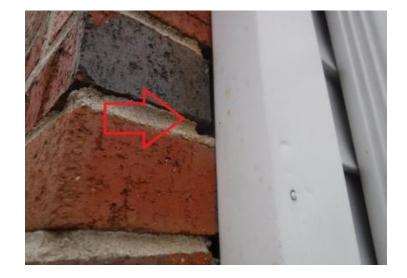
Gaps noted between brick and vinyl siding along the front porch and at the front right corner of the home. Recommend having a qualified person properly seal the gaps to eliminate water penetration.

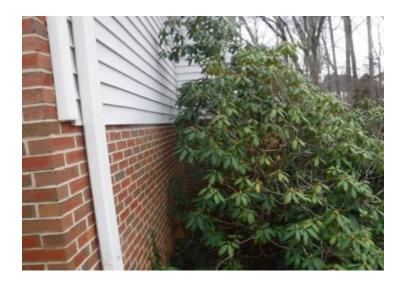
Recommend trimming bushes and vines away from the house.

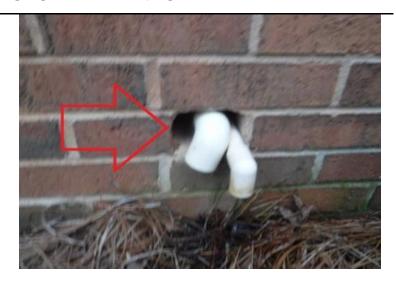
Recommend sealing gaps in siding where pipes enter the right side of the basement.

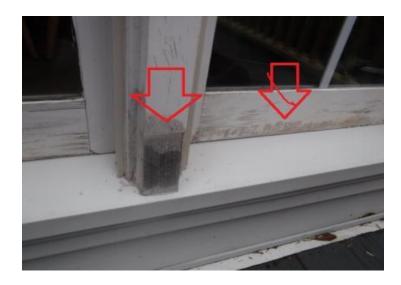
Paint is peeling from exterior windows and window frames around the home. Recommend having a qualified person paint the windows and frames with proper preparation.

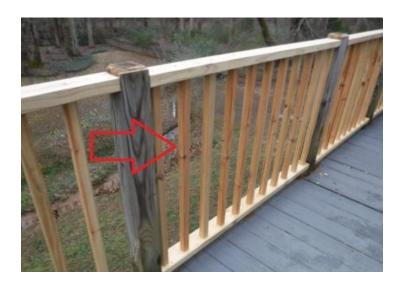
Recommend pressure washing and applying a wood preservative to the deck and deck railings.

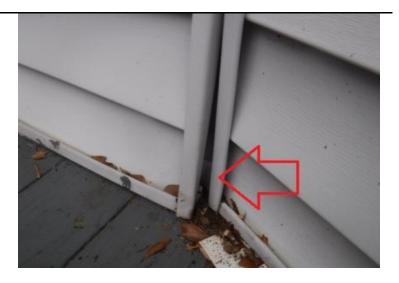
Bottom row of siding is loose along the rear deck. Gaps noted in corners of the siding. Recommend having a licensed contractor properly install the bottom row of siding

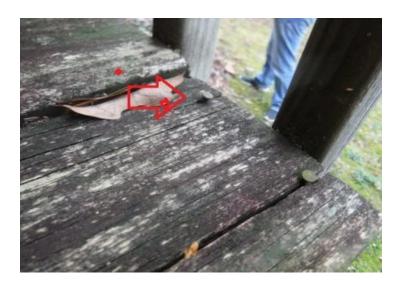
Raised nails noted along the left rear stoop and stoop steps. Recommend having a qualified person secure the loose nails in place to prevent injury.

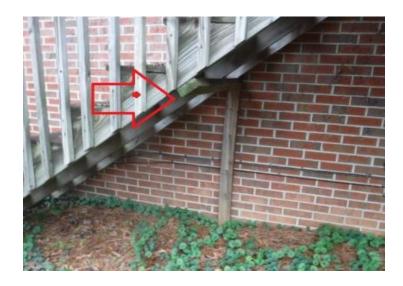
A partial brace has been installed under the stairs at the left side stoop. Recommend having a qualified person finish the brace to add proper support to the stairs.

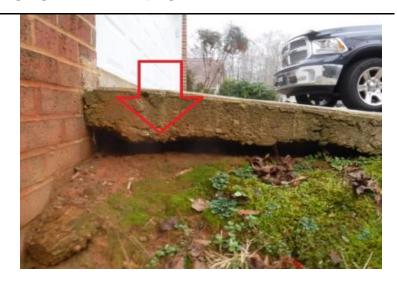
Voids noted under the driveway along both ends of the garage. The driveway has settled. Recommend having a licensed contractor evaluate the driveway and make necessary repairs to the driveway.

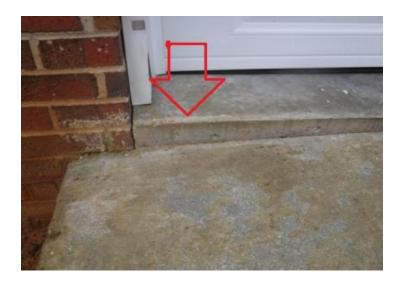
Voids noted under the driveway along both ends of the garage. The driveway has settled. Recommend having a licensed contractor evaluate the driveway and make necessary repairs to the driveway.

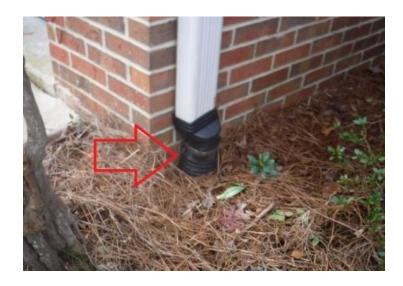
Unable to determine where downspout drain pipe discharges along left side of the front porch. Check with the current owner for location of the downspout drain pipe to ensure water is properly diverted away from the sidewalk.

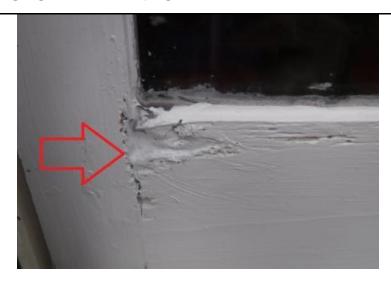
Wood rot noted along the exterior window frames at the front dining room windows. Recommend having a qualified person repair the damaged wood.

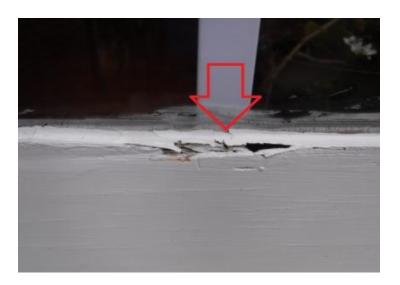
Wood rot noted along the exterior window frames at the front dining room windows. Recommend having a qualified person repair the damaged wood.

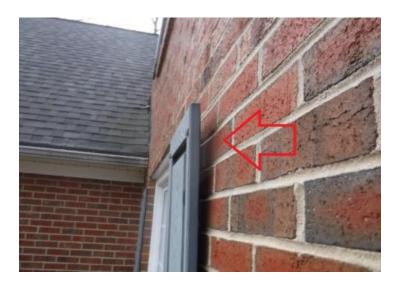
Window shutters are loose along front of the home. Loose window shutters need to be secured in place.

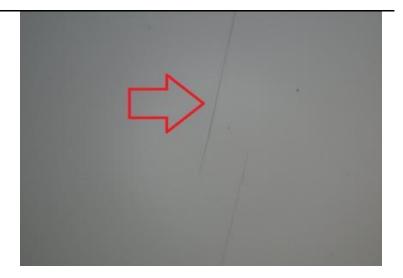
Settling cracks noted along the garage ceiling. Suggest patching the cracks.

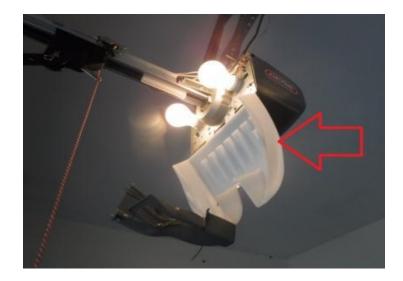
Lens is loose at the garage door opener. Recommend securing the cover lens in place.

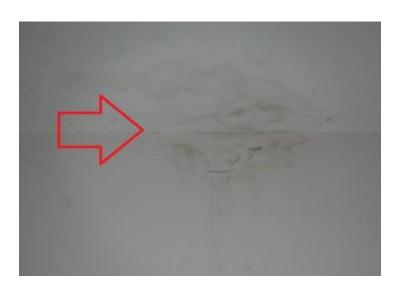
Water stains noted along the garage ceiling and wall. Newer roof appears to have eliminated leaks. Ceiling and wall are dry at time of the inspection. Suggest painting the ceiling and wall with proper preparation.

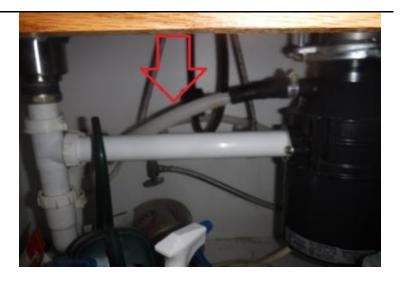
A visible high loop is not present at the dishwasher drain line. Recommend having a qualified person install a high loop or an air gap at the dishwasher drain line to prevent water from backing up into the dishwasher.

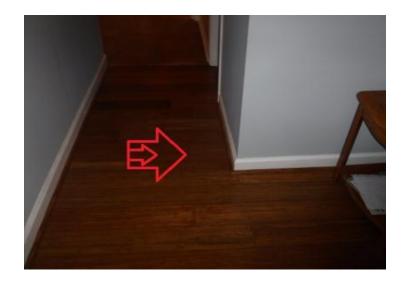
Slope noted to the first floor hallway beside the hall bathroom. Finished ceiling in the basement under this area prevents viewing the floor framing. Flooring feels secure.

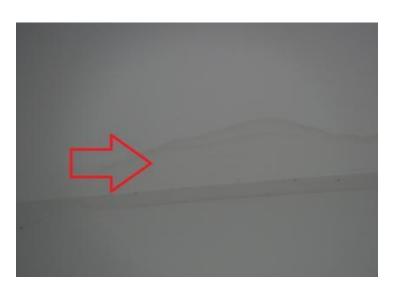
Water stain noted to the front coat closet ceiling. No evidence of active leaks observed over this area. Ceiling is dry at time of the inspection. Suggest painting the ceiling with proper preparation.

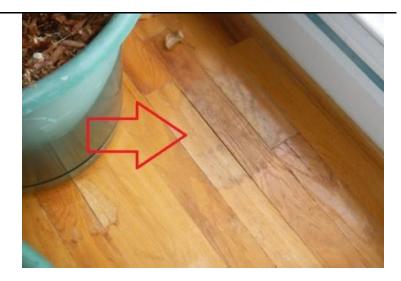
Water stains noted to the wood flooring in the front office. Recommend repairing the flooring.

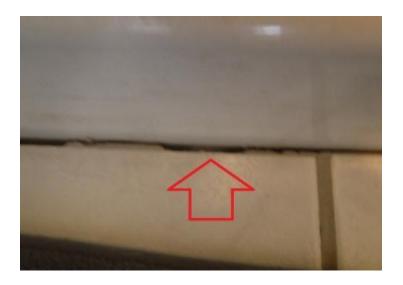
Recommend sealing gap between the shower and floor in the master bathroom to prevent water penetration.

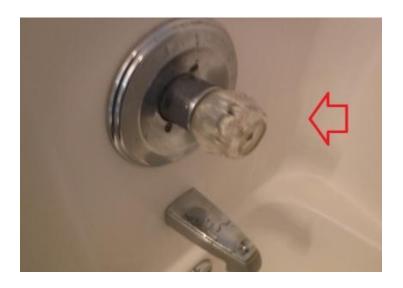
Bathtub faucet handle runs when turned to the off position in the second floor front bedroom bathroom. The handle must be turned back slightly to turn the water off. Recommend having a licensed contractor repair or replace the shower faucet handle to allow the faucet handle to properly tun off the water.

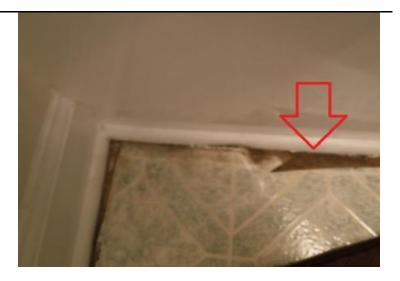
Vinyl floor is damaged beside the basement bathroom bathtub. Recommend having a qualified person replace the damaged vinyl flooring.

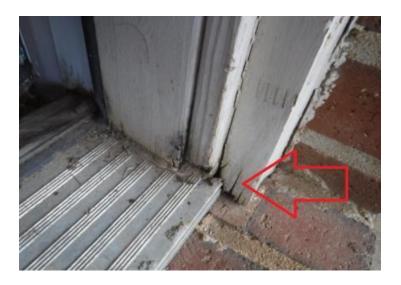
Wood rot noted to casement at the rear basement entry door. Recommend having a qualified person repair the damaged wood.

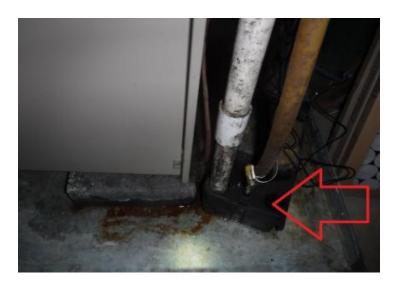
Standing water noted in the drain pan of the basement furnace. The furnace sump pump is not operating. Recommend having a licensed contractor replace the sump pump.
